**Creek Restoration
Swanson Hydrology + Geomorphology,**

Project: Hillside House Development Project **Date:** August 20, 2008;
Revised January 16, 2009

Subject: **City comments on proposed Conceptual Enhancement Plan for Arroyo Burro Creek (August 2008)**

Arroyo Burro Creek Enhancement Plan Hillside House Development Project

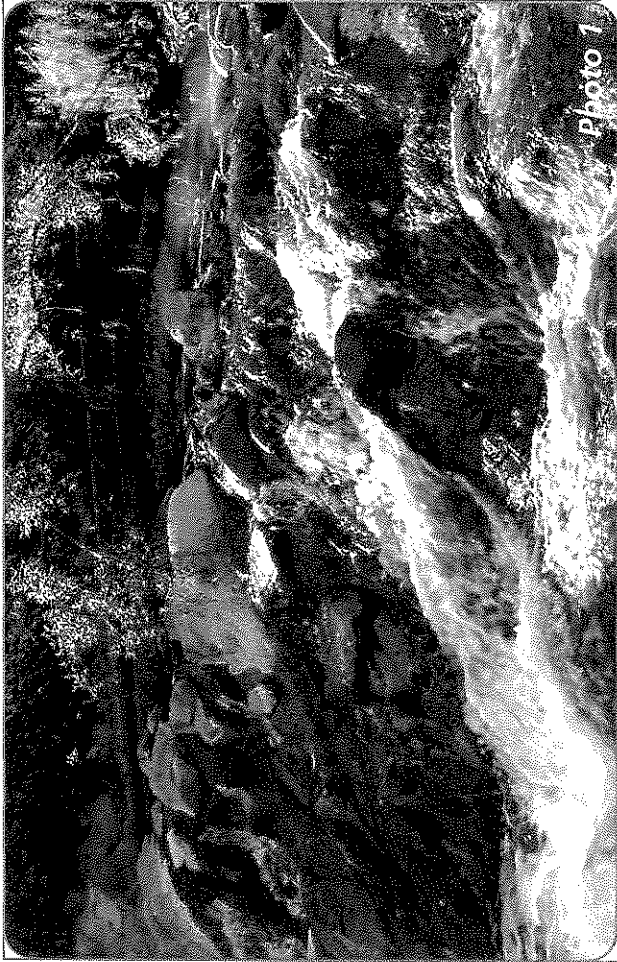
Photo 1

Response: SH+G reviewed field notes from the Project site and work conducted for the proposed Veronica Meadows project downstream of the Project area. At the downstream end of the Veronica Meadows project there is a significant grade break (6-8 foot headcut). This area has been armored with rock and grout and is considered to be stable, if maintained (Photo 1). In the Veronica Meadows project area some headcuts and vertical instability has been observed, especially in the upstream portion of the reach. It appears that these headcuts are formed by landslides depositing material in the channel and creating temporary nickpoints (Photo 2 and 3). The effects of these headcuts on channel stability are probably localized because they are likely dispersed by natural erosion processes without significant upstream migration.

Photo 1: Armored headcut at the downstream end of Veronica Meadows project reach.

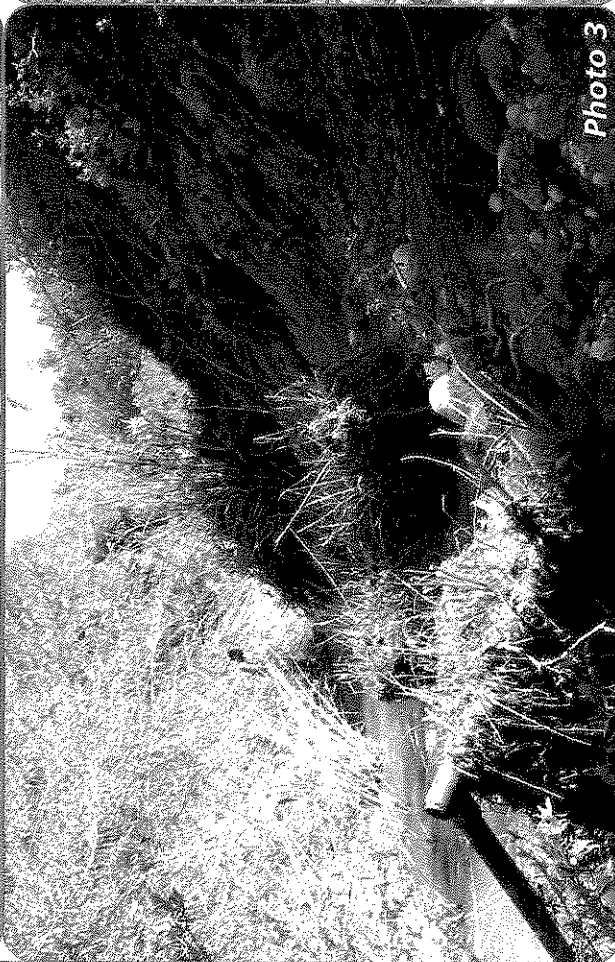
Photo 3

Photo 3: Landslide contributing material to Arroyo Burro Creek forming headcuts.

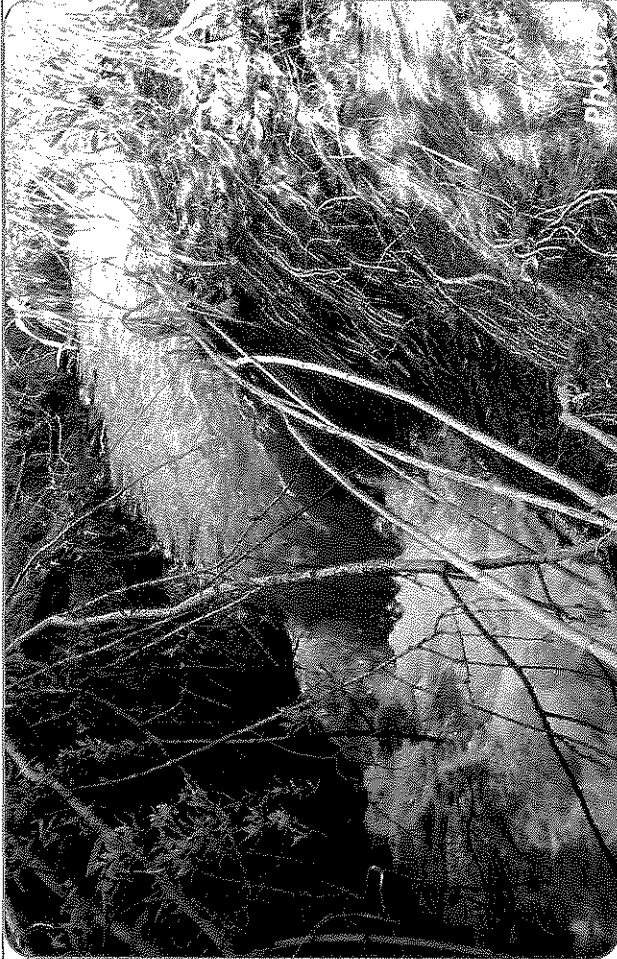
Photo 2

Photo 2: Active headcut at the upstream end of the Veronica Meadows project reach.

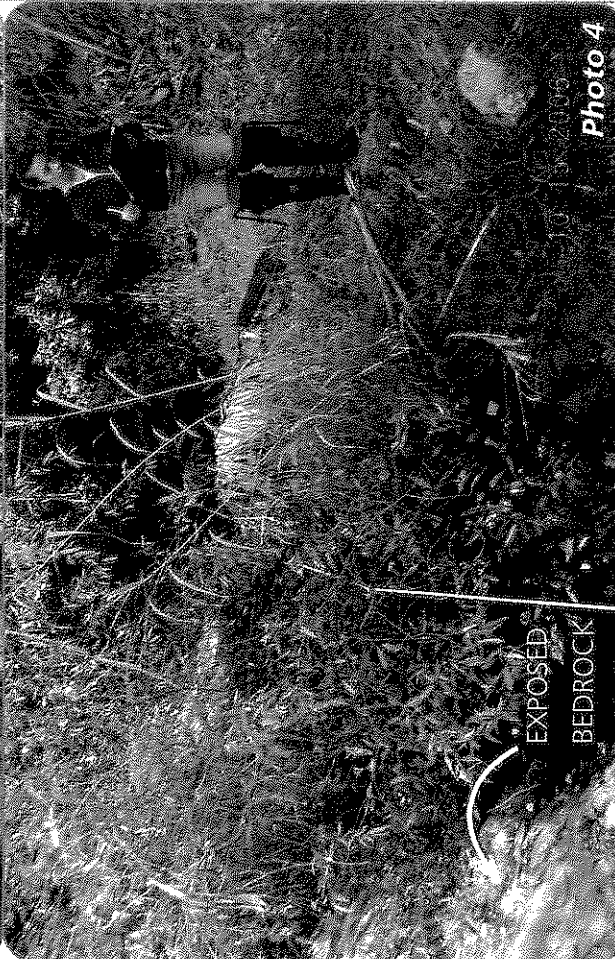
Photo 4

For the bank stability analysis in the Project reach SH+G surveyed from the Arroyo Burro-Las Positas Creek confluence through the upstream end of the Project. No significant headcuts were observed. At the downstream end of the Project reach there is some bedrock exposed at the surface (Photo 4), suggesting some localized grade control, but the extents and influence of the bedrock are unknown. Given that the channel is incised and no significant headcuts were observed, lateral migration (i.e., widening, bank failure) is likely to be the dominant channel development process in the near term. Thus, we believe significant changes in the longitudinal profile though the Project reach are unlikely in the foreseeable future, and therefore grade control to protect from further incision is not needed at the Project site.

Photo 4: Exposed bedrock at the downstream end of Hillside House project reach.

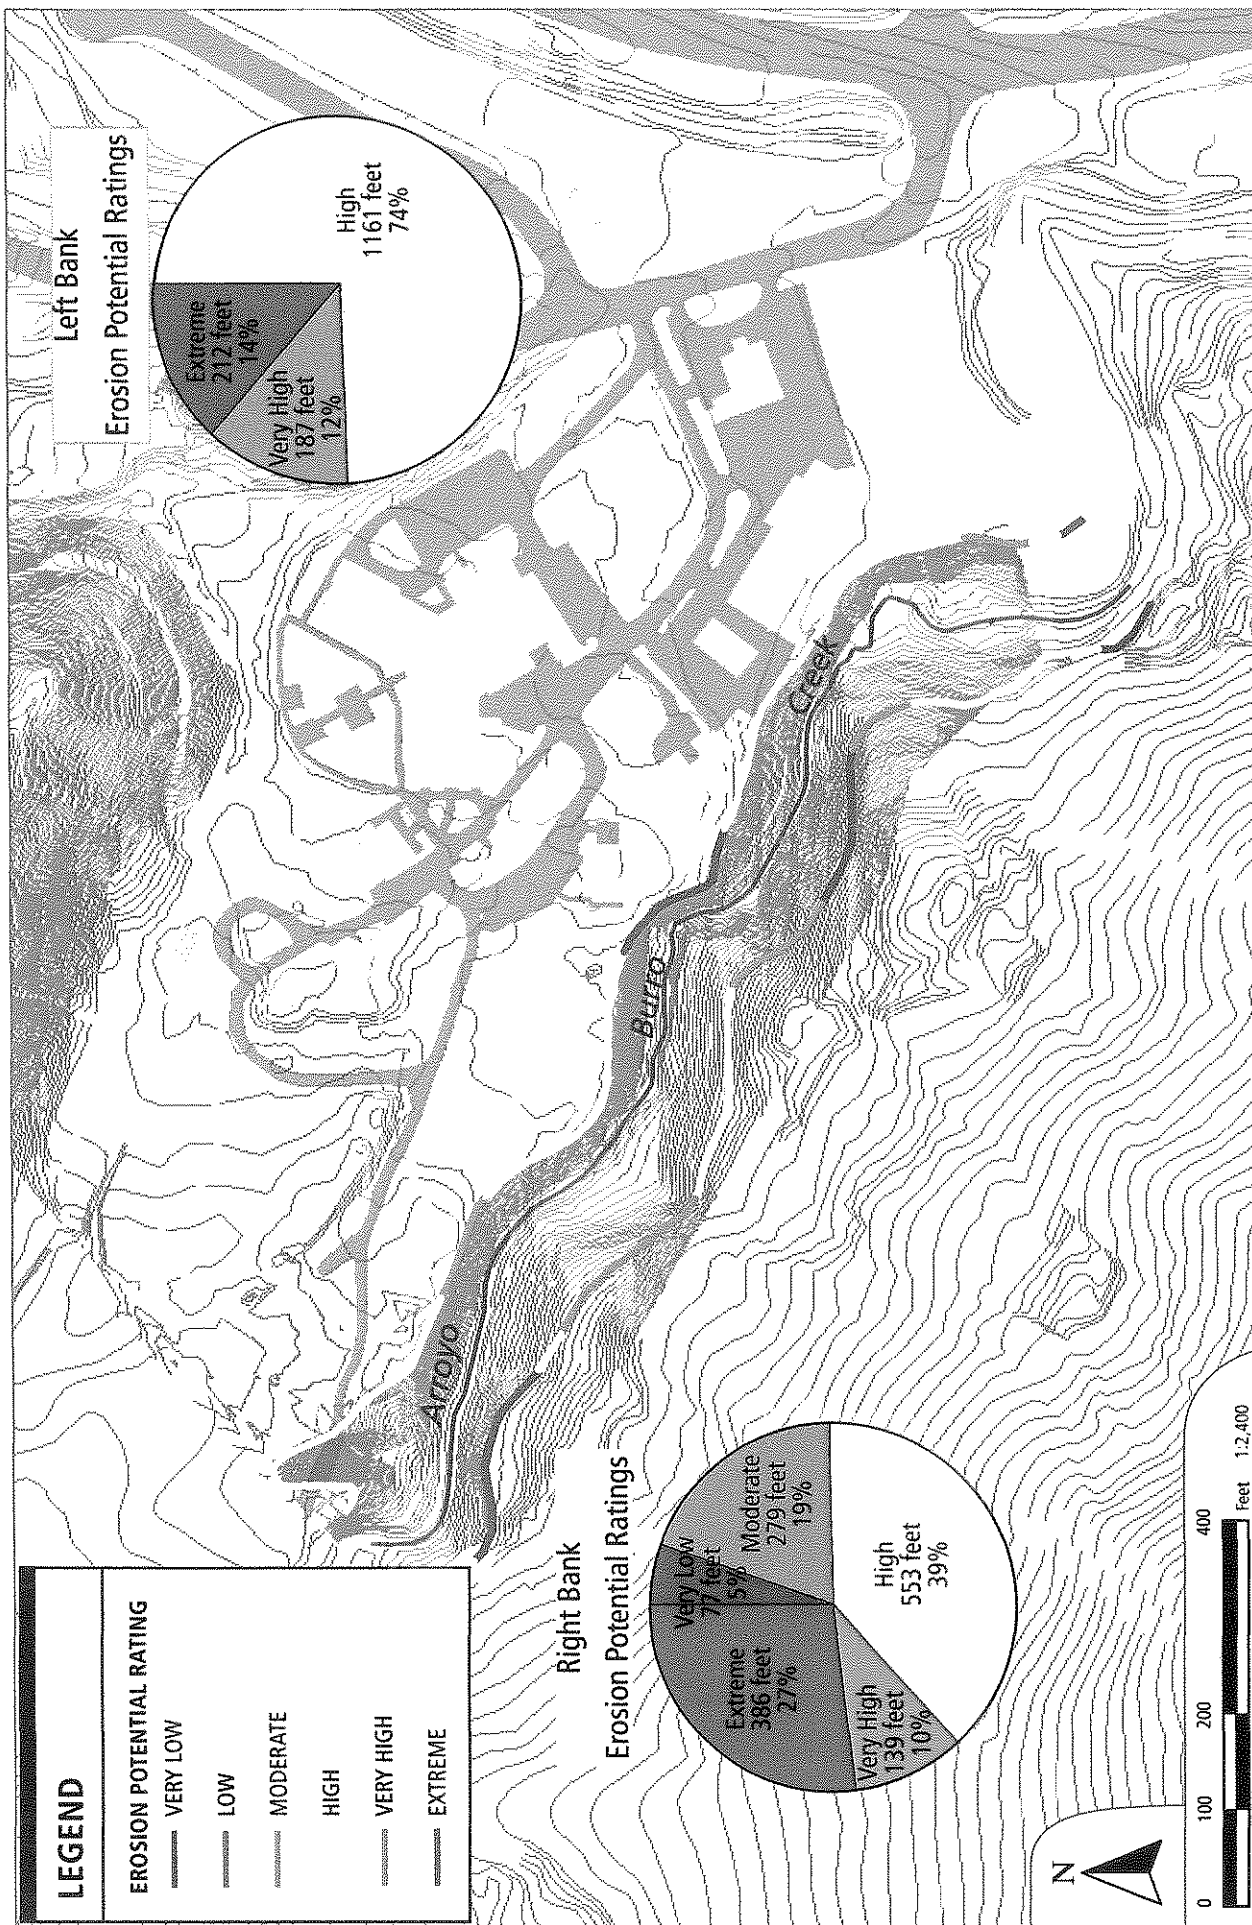
As shown on **Figure 3** and **Table 2** the entire left bank and more than 75% of the right bank had an erosion potential rating of ‘High’ or greater. This is primarily due channel incision, which is reflected in the ratio of streambank height to bankfull stage (Tables 3a and 3b). Incised channels have high erosion potential because they concentrate hydraulic force and tend to have steep banks where vegetation has difficulty establishing and/or persisting. In the Project reach banks that are protected by vegetation, with greater rooting depth/density, and/or less severe bank angle rated lower on the erodibility scale. In summary, channel incision, along with unstable geologic conditions (i.e., landslides), have yielded highly erodible streambanks. The enhancement plan presented in the following section seeks to improve the bank stability in the context of the environmental setting and proposed Project.

FIGURE 3: Results of the bank stability survey for the reach of Arroyo Burro Creek adjacent to the Hillside House development. Data were collected in mid-October and included: bank height, bankfull height, bank angle, percent bank face protected, root density and bank D_{50} .
